Field Report for Airborne Data Collected In Support of US EPA Region 6 South 4 Group Fire 1 December 2019

Flight Results for Flight 8, 1 December 2019

Flight Results for Flight 9, 1 December 2019

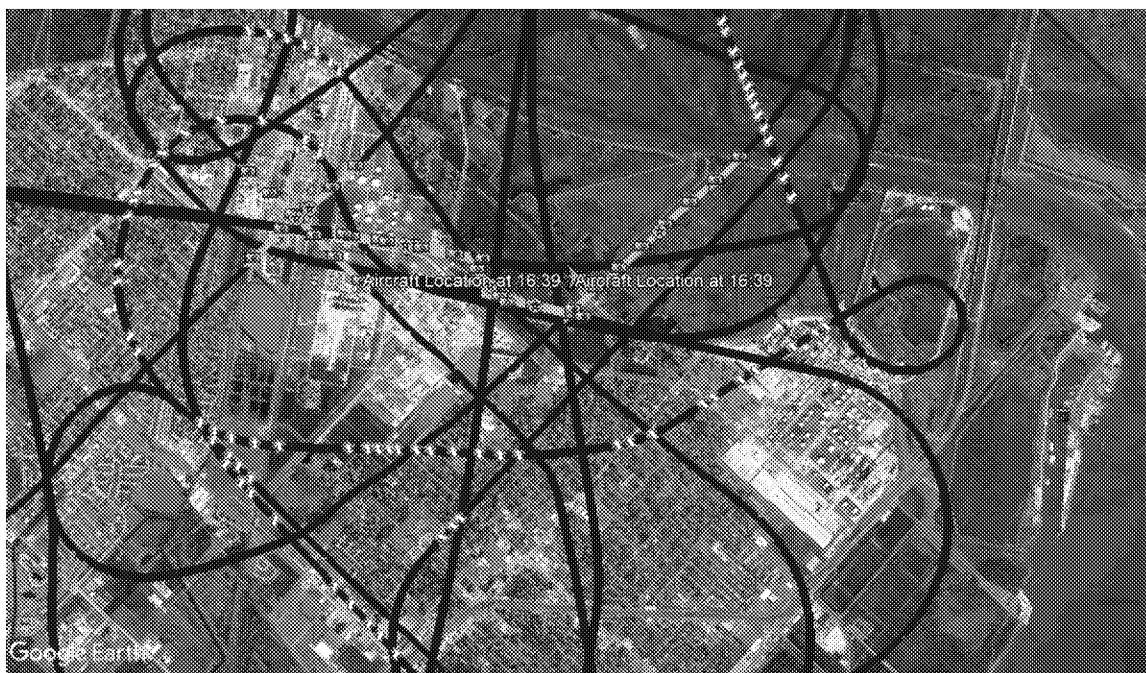
Figure 2: Data collection passes, Flight 8, South 4 Group Fire, Port Neches, TX. The blue lines represent the ASPECT flight path, green lines represent when the FTIR was actively collecting data, the yellow icons with star is the centroid of the line scanner image, and the camera icons represent when a photo was taken.

The order to launch flight 6 was given at 0845 central on 01 December 2019 with the aircraft reporting wheels up at 0906. The initial data collection run over the site was at 0926(central). The aircraft made a total of 7 data collection passes; flight information is summarized in Appendix Flight #8 and Figure 2.

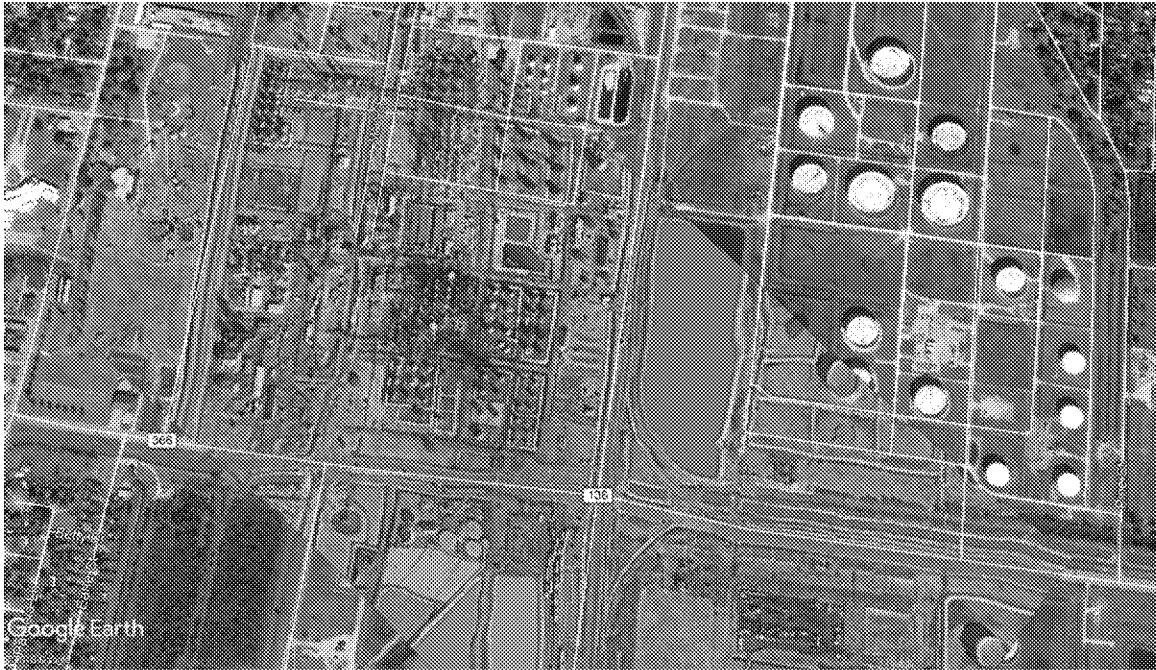
A total of 2 test and 7 data collection passes were made in the proximity of the fire and an infrared line scanner image was generated for each pass. Figure 3 shows a typical 3-band infrared image obtained from data collected for Run 4. The image was obtained by flying directly into the wind to provide the best possible image quality. In a similar fashion as to flight 7, the overall thermal content of the image is low with only isolated higher than background (white) locations. Figure 4 shows a close-up thermal analysis of the production facility.

Figure 3: – 3 band IR image, Run 8, South 4 Group Fire

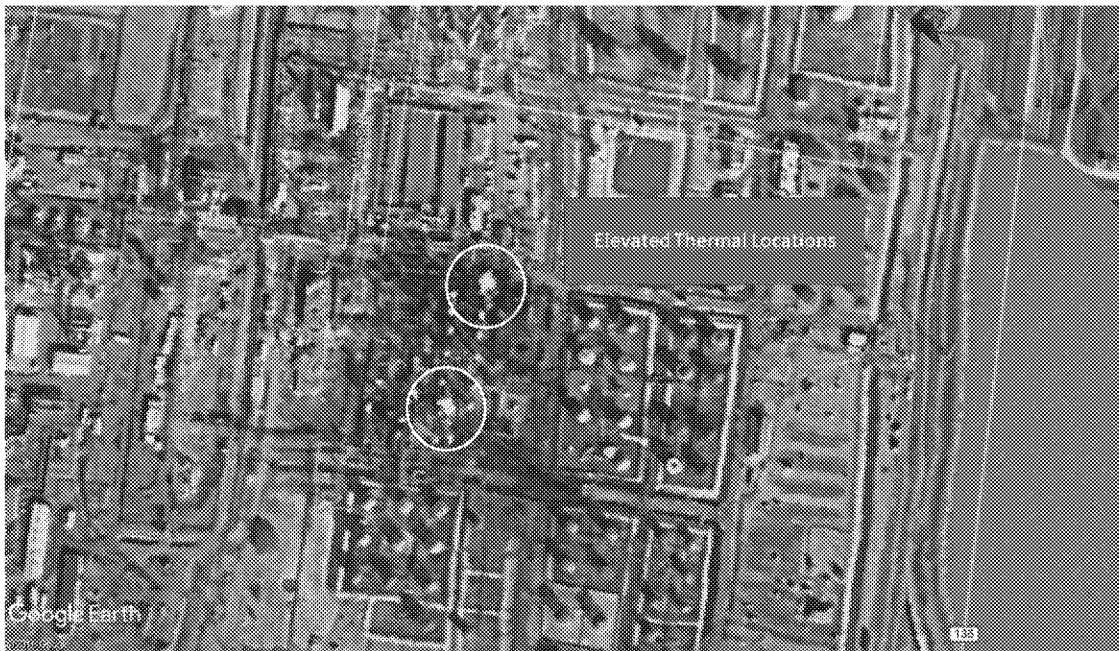
Figure 4 shows a close-up of the facility. The white content of the image shows the hottest targets which corresponds to reactors, piping, and tanks within the production unit. Close examination of the image does show the presence of water streams directed into the unit. There does not appear to be any plumes leaving the site.

Figure 4: -- 3 band IR Image, Run 8, South 4 Group Thermal Image

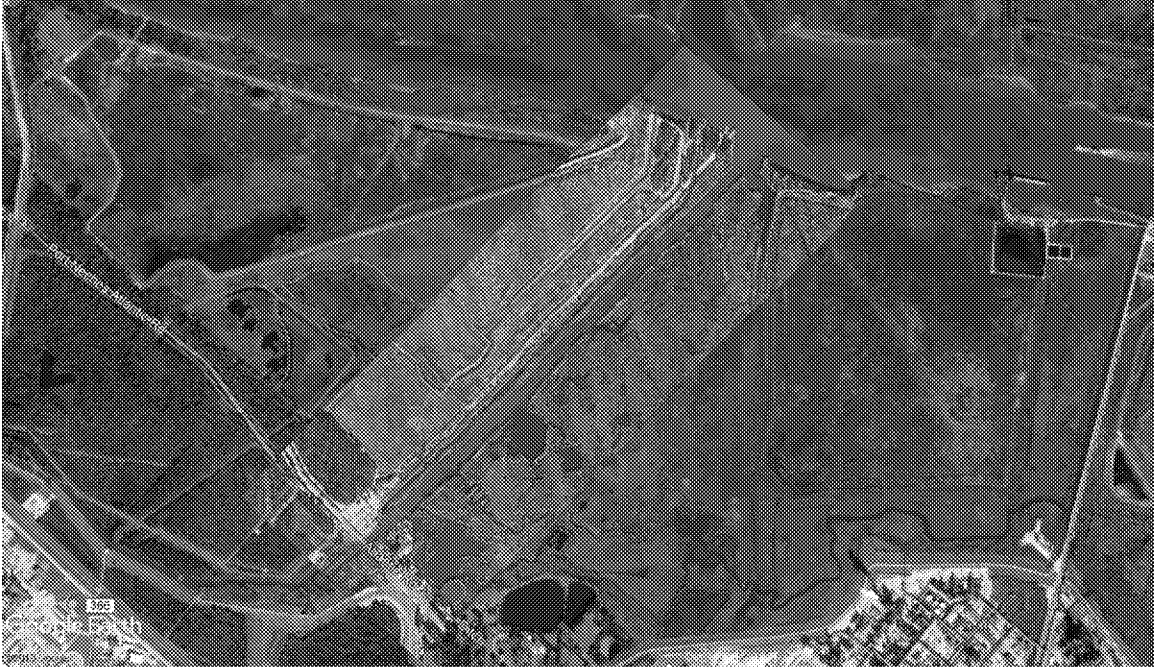
To check for possible oil migration from the site, ASPECT was flown along a waterway leading from the east side of the facility to the Naches River. Figure 5 show an IR image of the waterway flowing into the River. No sheen can be seen in the image.

Figure 5: -- 3 band IR Image, Flight 8, Run 8, Waterway Image, South 4 Group Fire

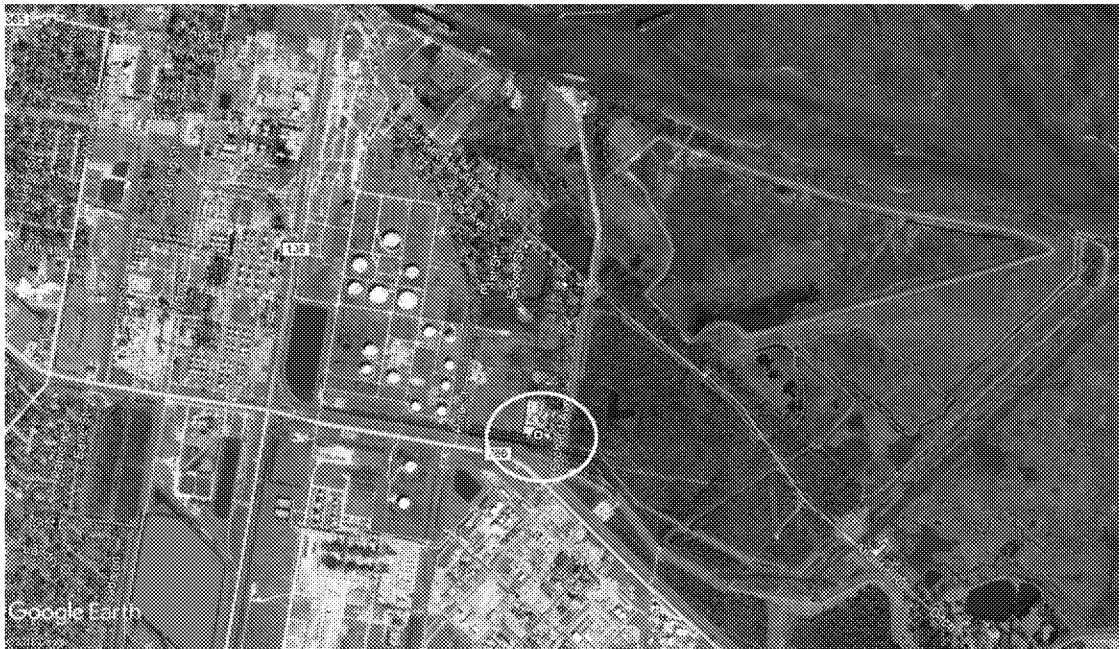
A low level detection of isobutylene was made downwind of the facility along the waterway east of the facility near the Orchard Ave bridge. The location of the detection is given in figure 6. Figure 7 shows a spectrum of the detection with the characteristic isobutylene peak at 890 wave number. The detection was very weak with an estimated concentration of 1 ppm. A summary of data of the data collection is given in table 3.

Figure 6: -- Isobutylene Detection, Flight 8, Pass 4, South 4 Group Fire

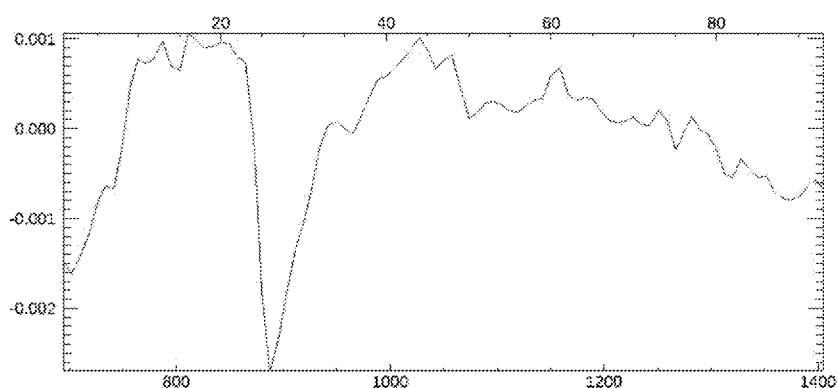
Figure 7: -- Isobutylene Spectrum, Flight 8, Pass 4, South 4 Group Fire

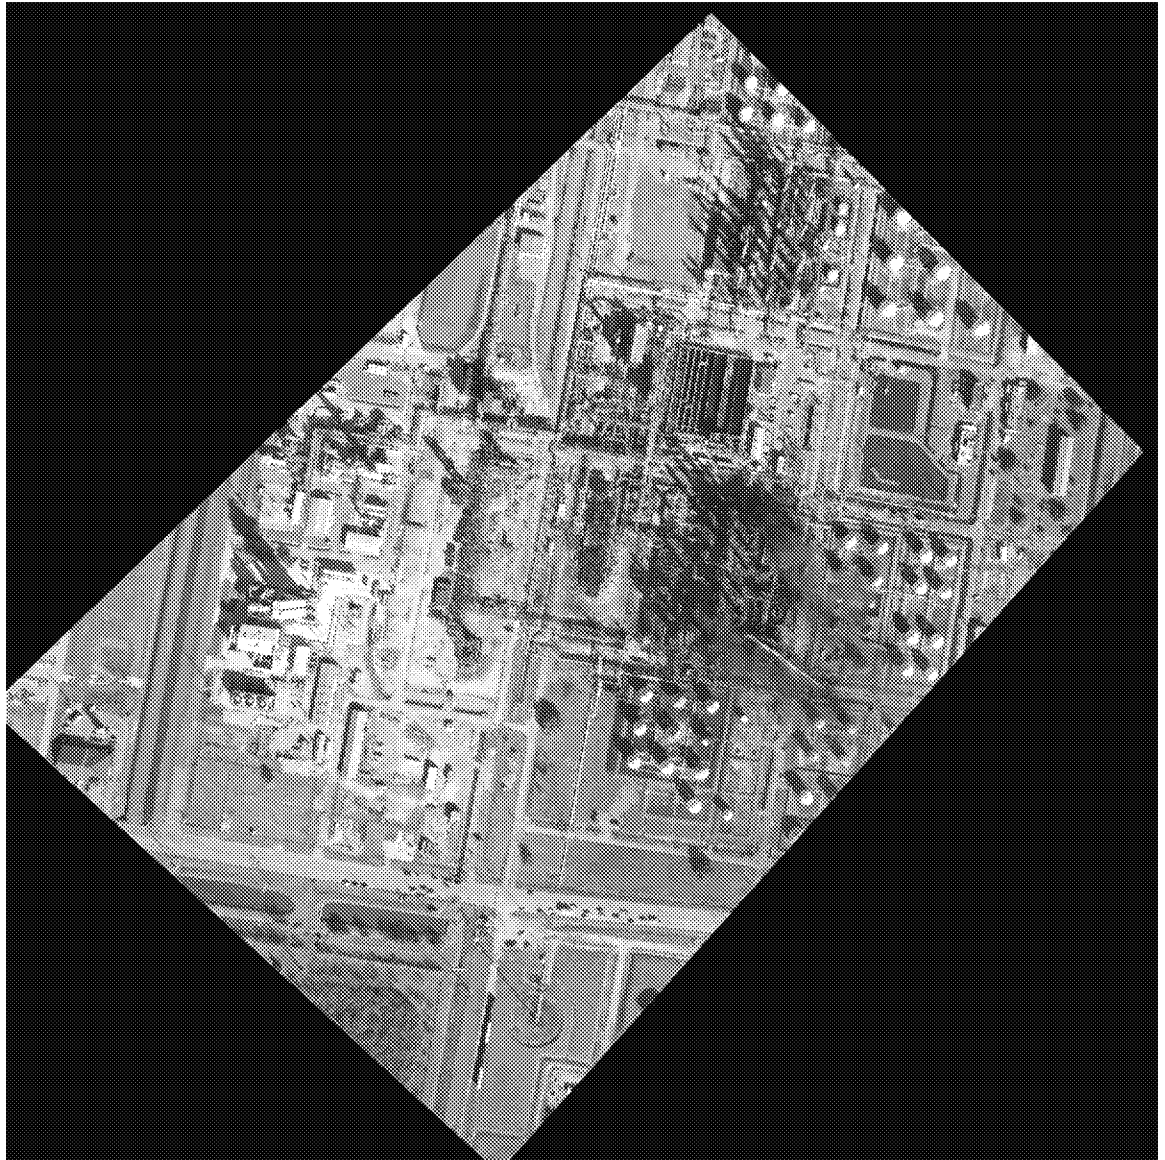
A full set of high resolution aerial digital photography were collected as part of the flight. Figure 8 shows a representative image collected as part of each pass. As reported by the crew, light grey smoke continues to be evolved from the site which is shown moving toward the southeast. This confirms finding from IR thermal analysis that elevated temperature regions continue to generate emissions. Light grey smoke can be seen leaving the site. The oblique image in Figure 9 shows the presence of at least two small fires and the continued presence of water cannon.

Figure 8: Aerial Image of the South 4 Group Fire, Flight 8, Run 4.

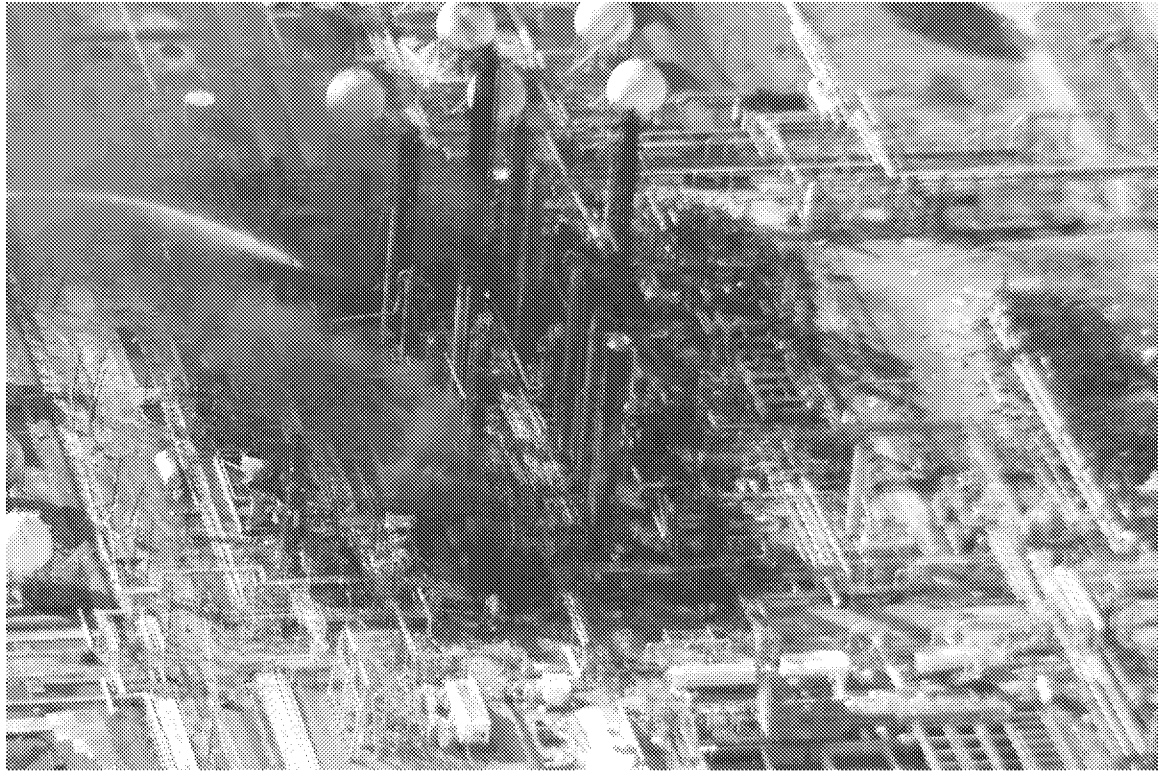
Figure 9: Oblique Image of the South 4 Group Fire

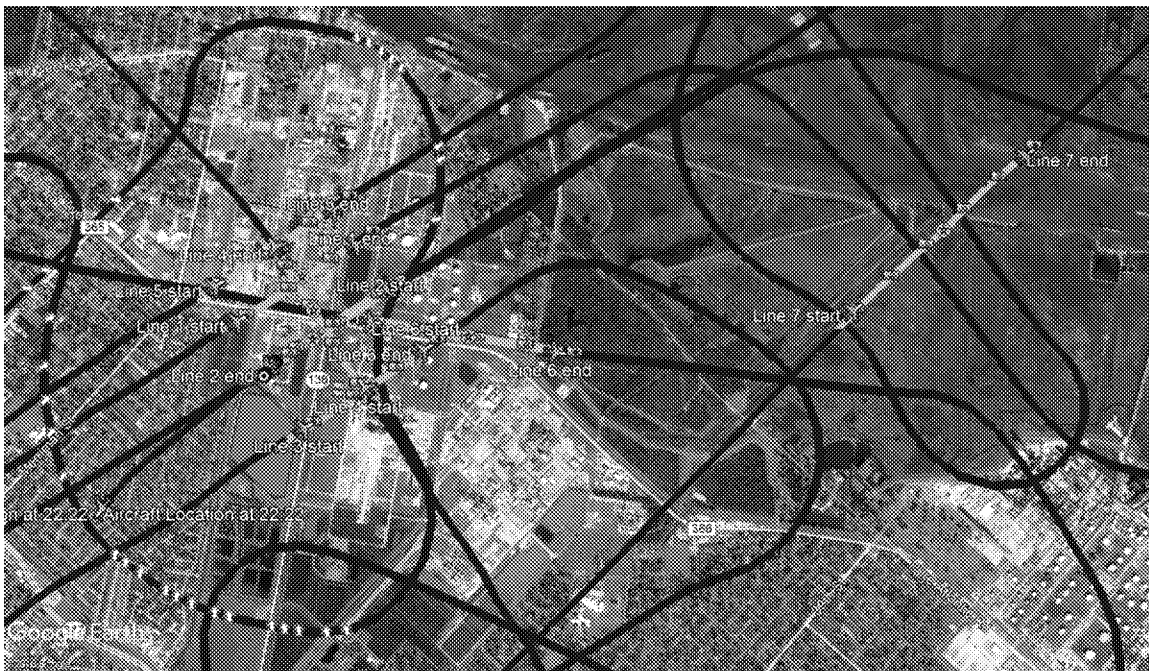
Figure 10: Data collection passes, South 4 Group Fire, Port Neches, TX. The blue lines represent the ASPECT flight path, green lines represent when the FTIR was actively collecting data, the yellow icons with star is the centroid of the line scanner image, and the camera icons represent when a photo was taken.

The aircraft was airborne at 1455 (central) was over the site at 1532 (central). A total of 1 test and 8 data collection passes were completed. Flight information is summarized in Appendix Flight #9 and Figure 10.

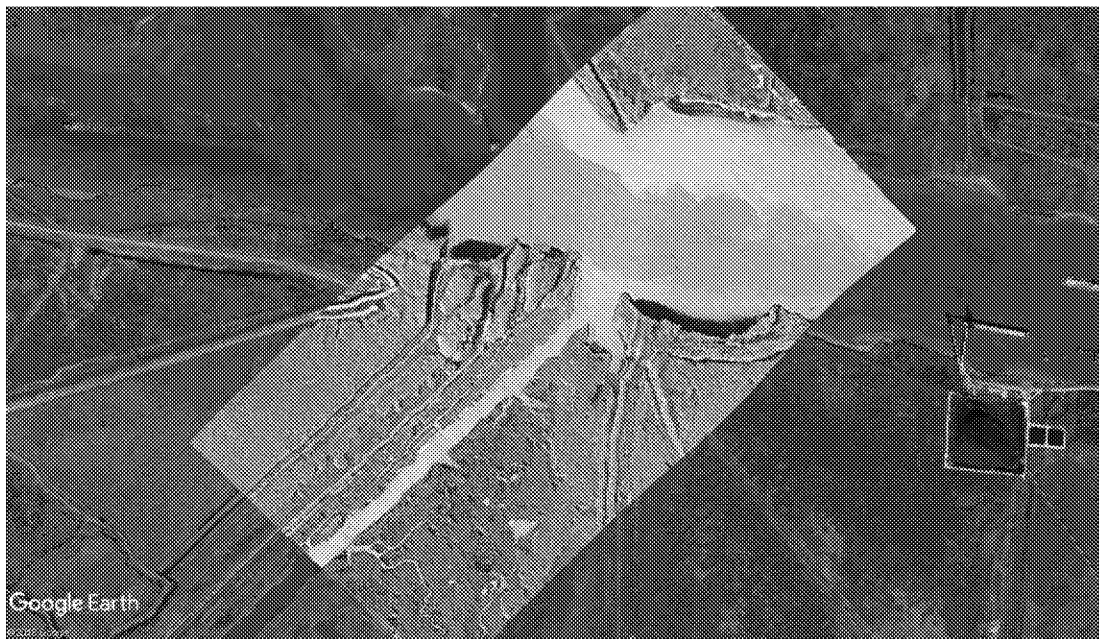
Figure 12: -- 3 band IR image, Flight 9, Run 8, Waterway, South 4 Group Fire

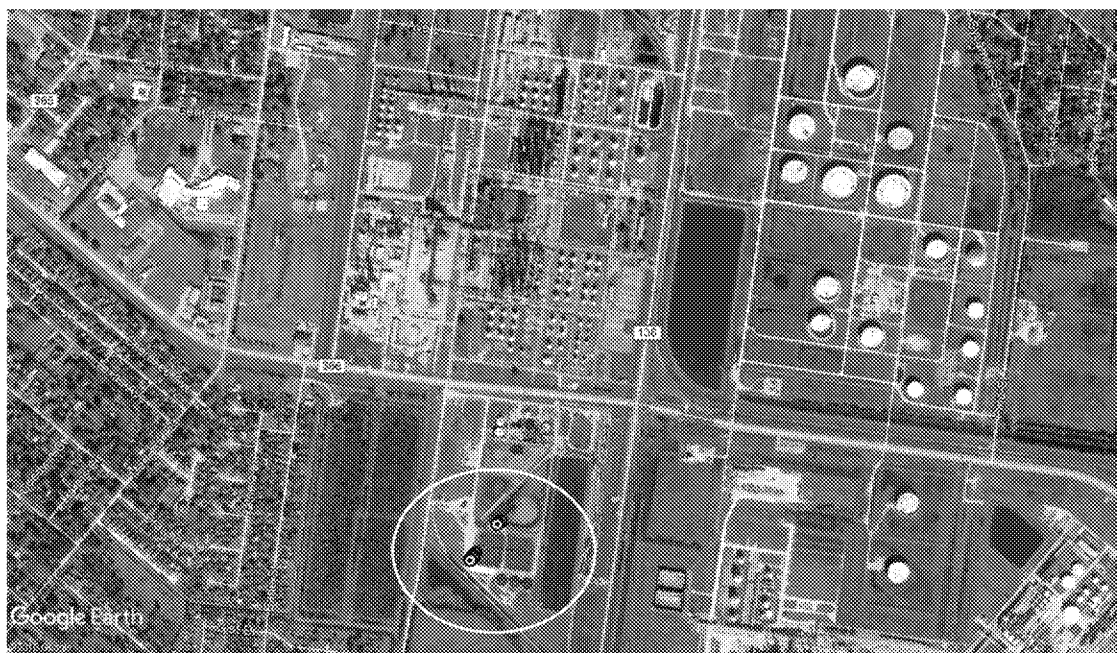
Signatures corresponding to isobutylene were detected almost due south of the facility. Figure 13 shows the locations of the detections near a wastewater treatment plant with detections made on two separate passes. Processed FTIR data indicated that these detections showed a maximum concentration of 1.7 ppm. An example of representative spectra is given in figure 14 showing the characteristic peak at 890 wave number. A summary of data of the data collection is given in table 6.

Figure 13: -- Isobutylene Detection, Flight 9, South 4 Group Fire

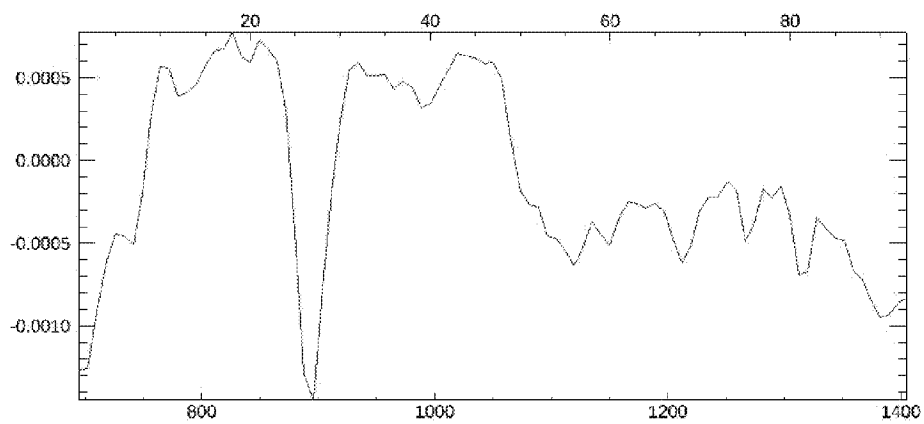
Figure 14: -- Isobutylene Spectrum, Flight 9, Pass 5, South 4 Group Fire

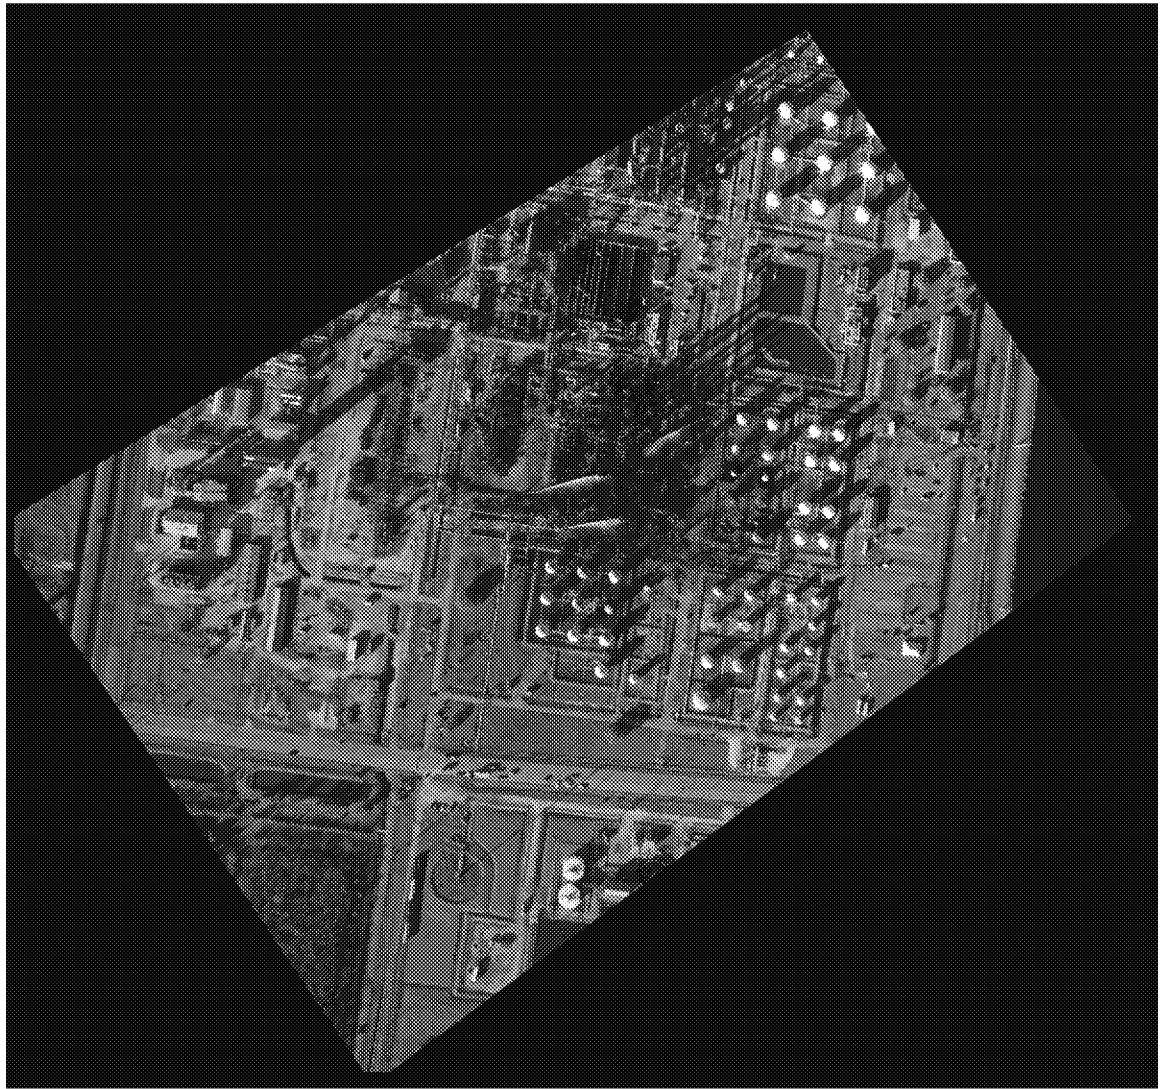
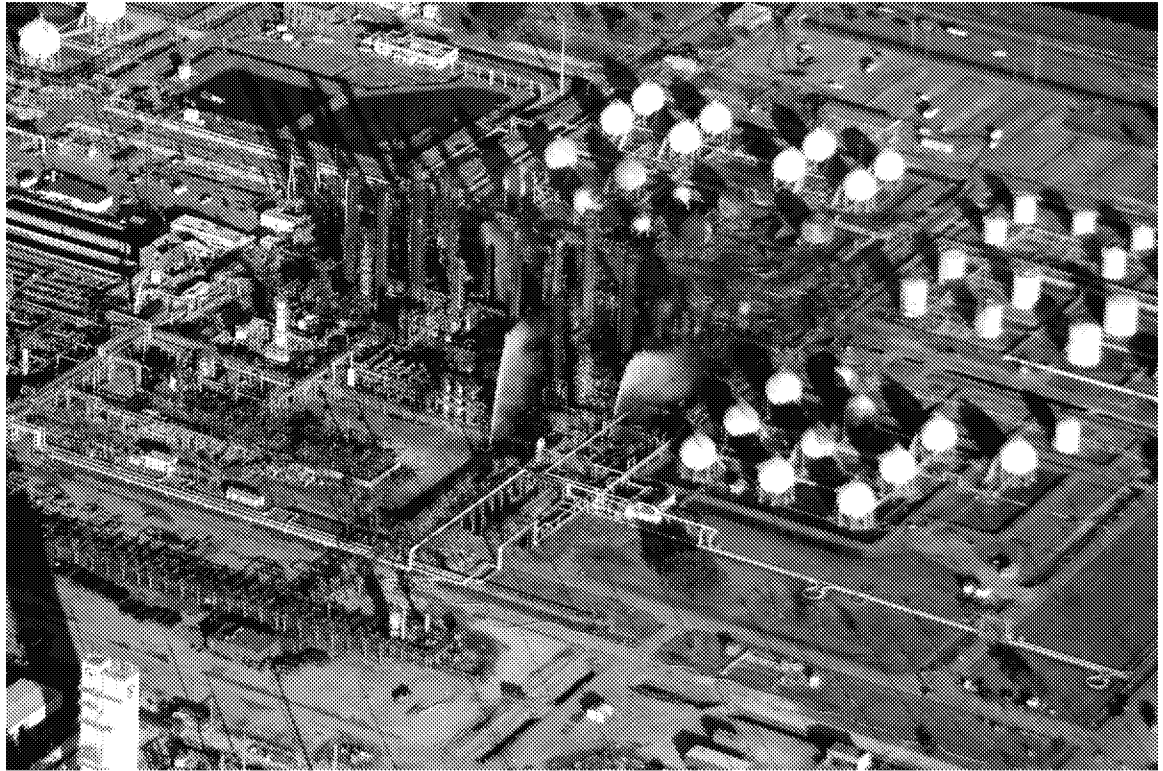
A full set of high resolution aerial digital photography were collected as part of the flight. Figure 10 shows a representative image collected as part of each pass. In a similar fashion as the morning flight, the image shows a weak plume being emitted from the facility. At the time of collection, three water cannons were in operation. An oblique image collection as part of the mission is given in figure 16. Water cannons are visible with minimal smoke leaving the site.

Figure 15: Aerial Image of the South 4Group Fire
